FTA Air Conditioning Systems: The Real Reason Your Condenser Fan Relay Keeps Failing

By Kevin Crozier

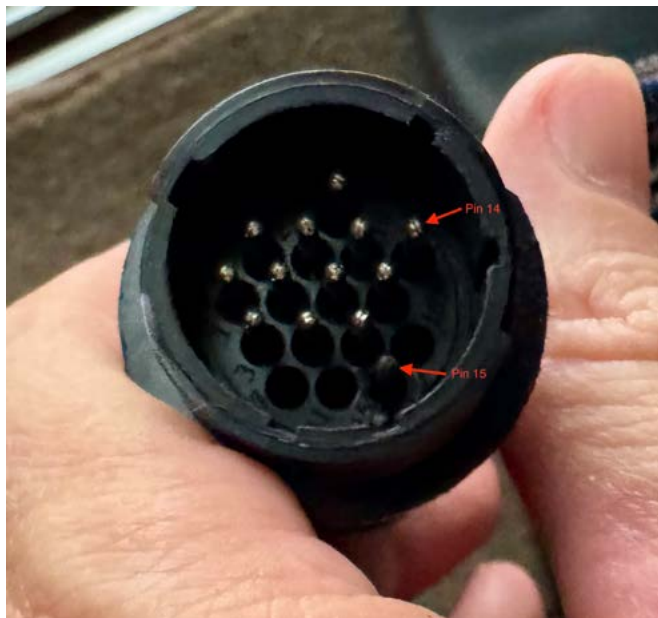
Photo 1: The relay module connector with the damaged pin 15 and the populated pin 14

Here's the root cause: On the relay module harness side, the relay fan output is wired to two pins, pin 14 and pin 15, in the connector (**Photo 1**). The current load is designed to be split. However, on

the FTA main harness side, FTA only populated one of those pins, pin 15, in the connector. That forces all the condenser fan's current through a single contact that was never meant to handle upwards of 15 amps alone (the connector pins are rated for 10 amps).

Over time, that single pin gets hot. The pin gets damaged, and it starts arcing. The connection weakens, eventually the relay burns up—taking the condenser fan out of service.

Swapping relays repeatedly won't fix it. The damaged connector pin will continue to cause the relay to fail (and may even cause damage in the ECU, the electronic control unit). Before replacing the relay, open the connector and look for discoloration, pitting, or melting around pin 15 – it will be obvious (**Photo 2**).

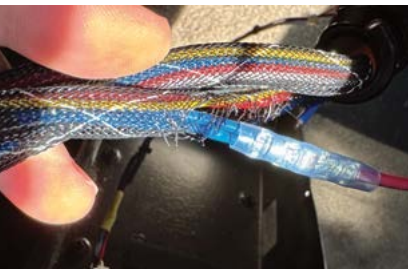
Photo 3: The splice in the relay module harness, bypassing pins 14 and 15

The simplest solution is to bypass the connector for the condenser fan circuit. Under the supervision of a qualified A&P, splice a wire from the relay module harness, specifically the two blue wires connected to pins 14 and 15 (**Photo 3**) to the condenser fan feed wire in the main harness, which is a thicker blue wire connected to pin 15 (**Photo 4**). The other solution would be to replace the damaged pin in the connector, add the missing second pin to the main harness, and splice it into the condenser fan wire so the load is properly shared.

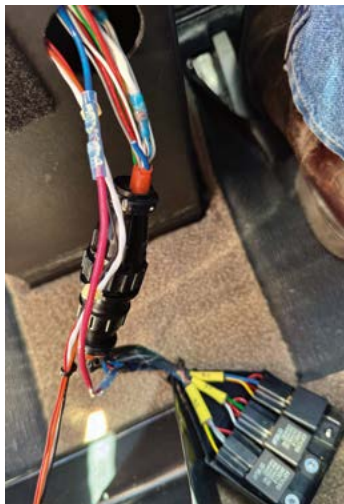
Photo 4: The splice on the FTA harness, bypassing pin 15
